WEAR GAUGE  
FOR FUELING  
ADAPTERS

BULLETIN 156  
(8-02)

## THIS GAUGE TESTS FUELING ADAPTERS FOR EXCESSIVE WEAR IN LESS THAN 1 MINUTE

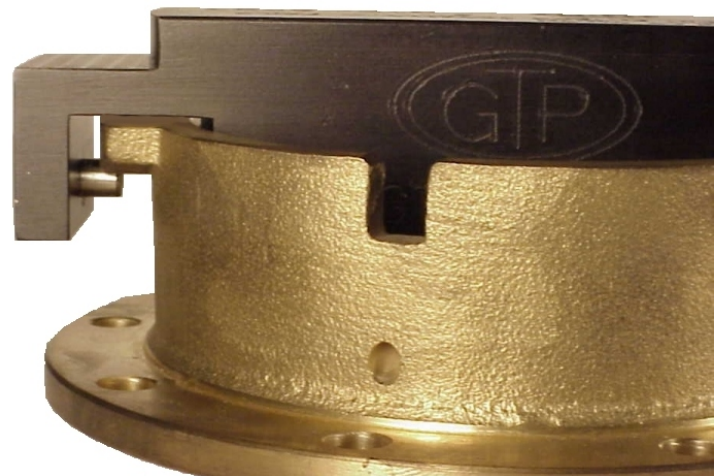
Leakage during refueling is often caused by excessive wear on the underside of the 3 lugs that are located on the outer edge of the fueling adapter. This wear reduces the sealing force between the nose seal of the refueling nozzle and the sealing face on the adapter.

To check for lug wear, set the gauge in the adapter and rotate it so that the gauging pin moves toward the lug. If the pin passes under the lug, wear is excessive.

Wear that develops on the underside of the three lugs is the most common problem. It causes leakage because it reduces the force on the seal between the nozzle and adapter. Our GTP-8963 wear gauge quickly determines whether the lugs are excessively worn. Each lug should be checked. If any of the three are overly worn, the adapter must be replaced.

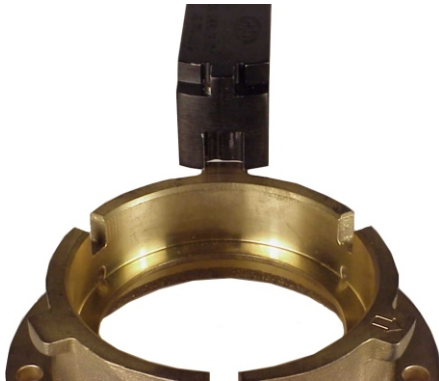
Lug width is important because excessive wear can result in a fuel spill in the same way as described for slot wear.

To check for lug width wear, use the groove in the end of the gauge. If the lug enters the groove, there is excessive wear.
